**JAMES CROSS**, Certified Marine Surveyor

Re: 1981 Lash 55 Fishing Vessel "LONG LINE"

This letter reports the results of a survey of the above vessel which was inspected while hauled on the 29th of June 2015, at the Newport Shipyard in Newport, Rhode Island. You requested the inspection to establish it's condition and value. I have made only a visual inspections of the engine, gears, and fishing gear.

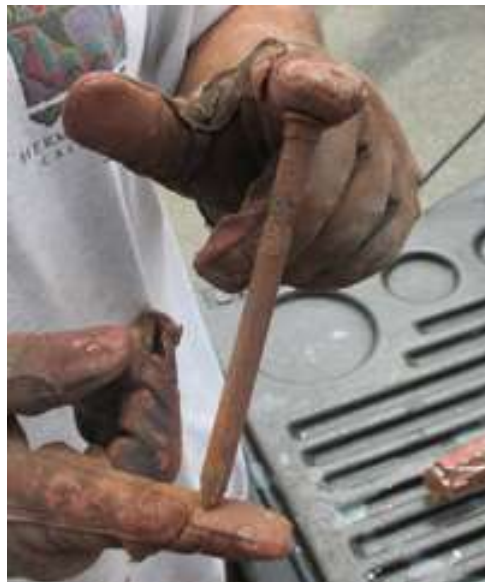
The primary fasteners are five inch by five sixteenth inch galvanized spikes. One shown on next page. This fastening system makes for a very sturdy basic hull.

*Fastener sample*

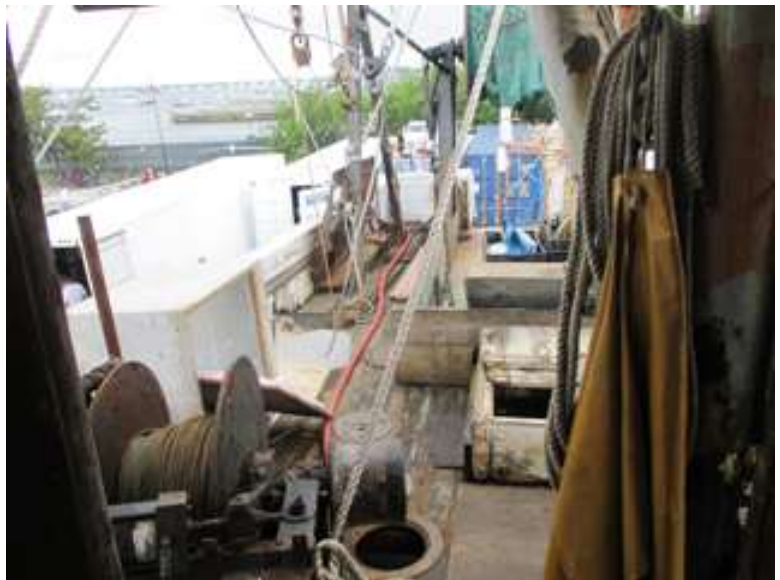
*Work deck*

All surfaces were checked out and no problems were found. The work deck, (photos on Page 3 and at left) is also constructed of white oak framing and transverse oak planking reinforced to accommodate load bearing areas. All deck supports and reinforcements are also oak and are well secured.

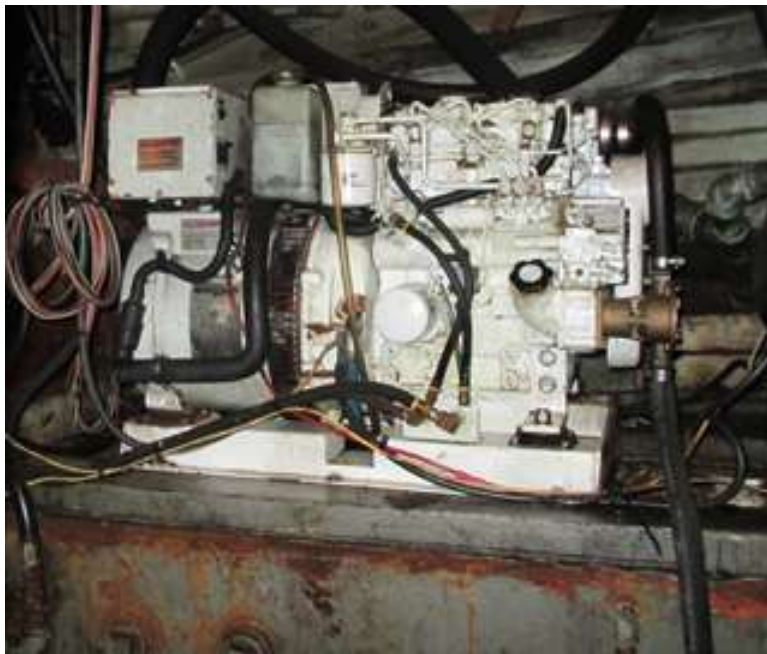
A ( pictured at left) Northern Lights 8 KW Diesel powered generator was also a recent upgrade.

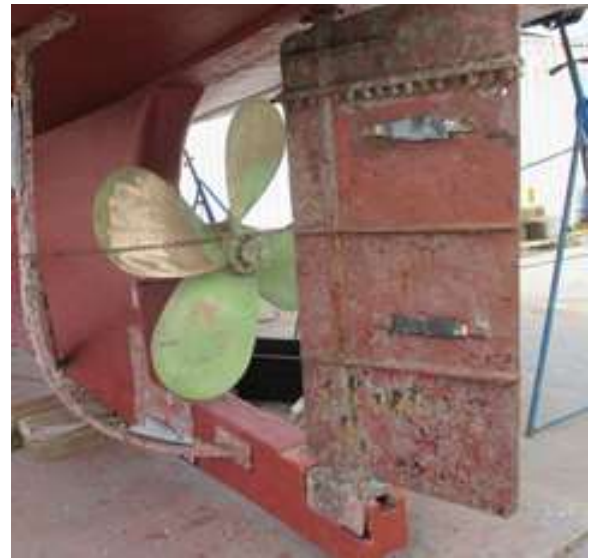
The engine controls from both stations are smooth operating. The engine compartment bilge is sound and sturdy. The bilge in this area is clean. There are three two inch high capacity dewatering pumps. One pump is hydraulic driven and the other two are DC driven. The custom hydraulic manual steering gear is in good condition and operates smoothly from both stations. The rudder shaft packing gland appears to need repacking.

*Rudder and propeller*

Free up tight through hull fittings. Remove unused wiring and harness and secure remaining wiring. Repack rudder shaft log. Protect batteries from shorting. Insulate exhaust system that passes through outside work space.

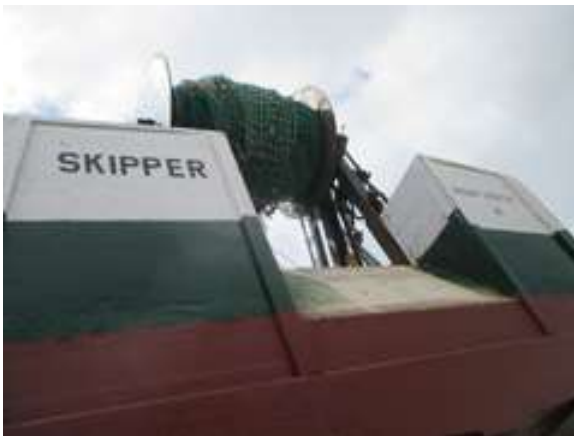
*View of transom*

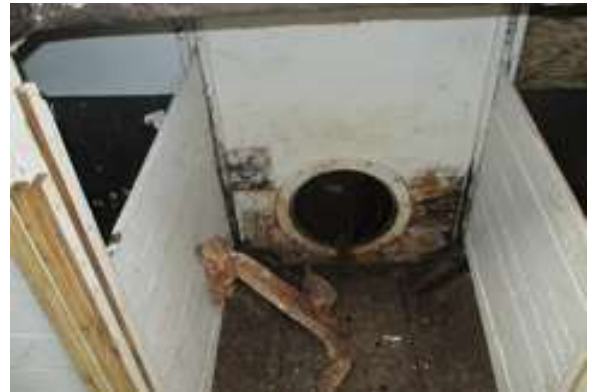
*View of one hold*

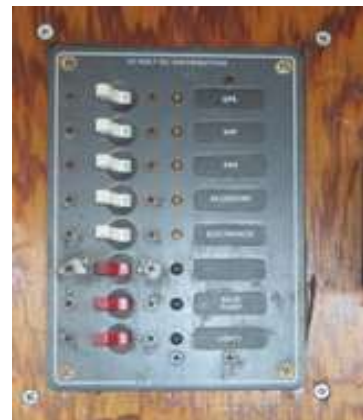
*DC control panel  
"LONG LINE"*

2. AC/DC Isolation..... Isolation system not installed, GFCI not installed
3. AC/DC ground system..... DC ground in accordance with ABYC standards,  
AC ground, as originally equipped (Closed loop system).
4. DC control panel..... original, at control station, well maintained. DC wiring is  
original stranded copper with original harnessing in place.
5. AC control panel..... In main salon in original condition.

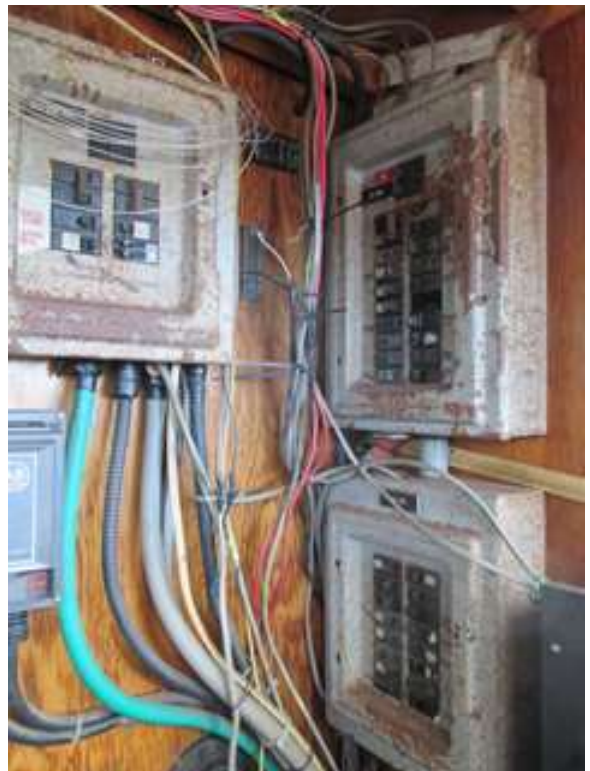
This report can not be construed to guarantee or warrant the condition or operational condition of the vessel. As mentioned earlier, this vessel is undergoing a refit while still in the working fleet. The AC electrical systems have yet to be addressed.

AC panels needing service

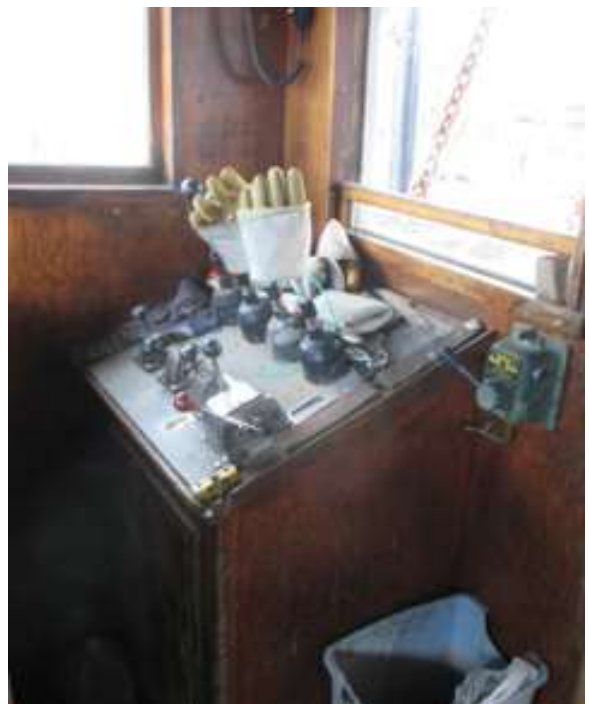
Secondary work operating station
