**JAMES CROSS**, Certified Marine Surveyor

Re: 2008 Grand Soleil 54 Sloop

This letter reports the results of a survey of the above vessel which was inspected on the 13th of May, 2015, while afloat at New England Boatworks in Portsmouth, Rhode Island . You requested the inspection to establish its condition and value.

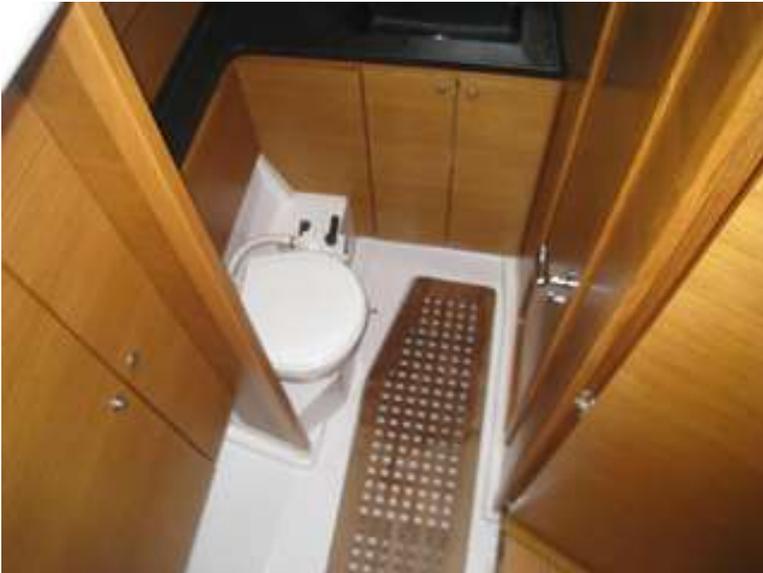
Both forward and aft heads are good sized and equipped with showers and marine toilets that discharges into holding tanks, or can be pumped overboard via a proper Y-gate. There are hand wash basin and fiberglass showers installed. No wood rot was noted in this area. The heads are finished in Cherry, Fiberglass, and Teak, and exceptionally clean. (Photo of one below)

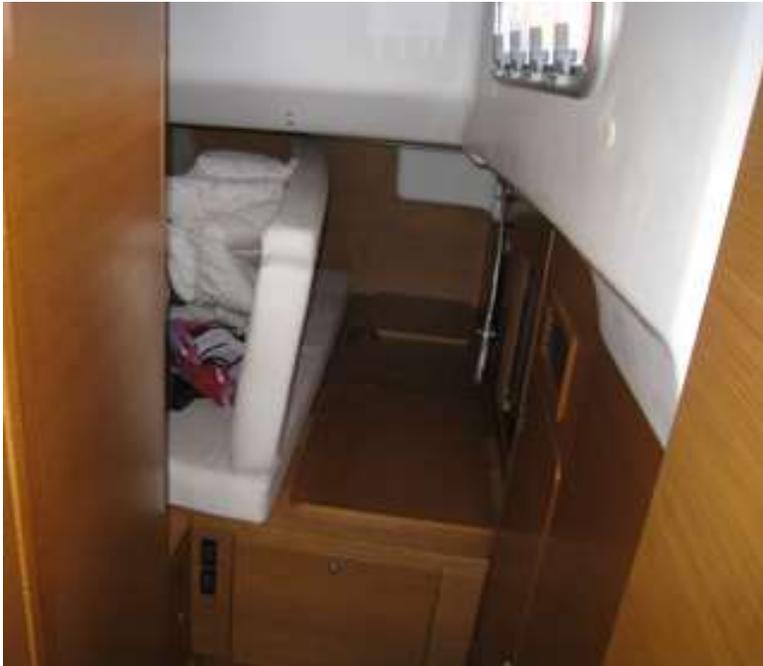
There are two Aft-Berth compartments located beneath the after deck. (one shown at left) These areas will sleep four. These areas are clean and nicely upholstered. There is adequate lighting and locker space in these areas. The escape deck hatches to these areas are tight to the weather and in good condition.

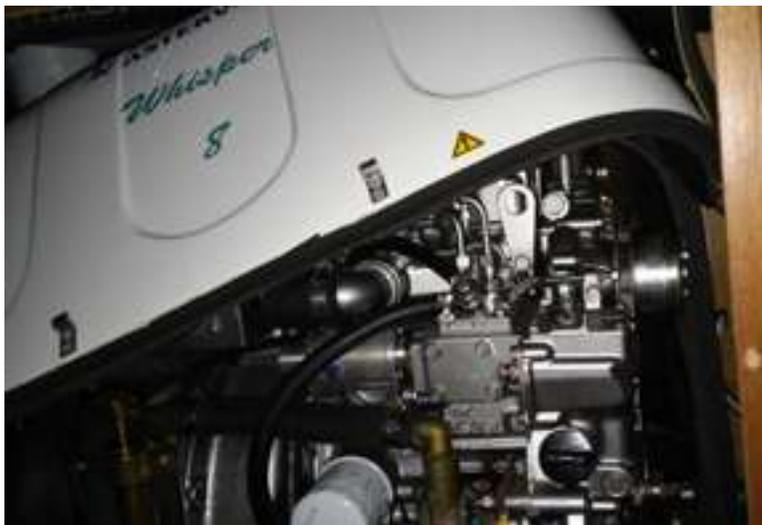
Propulsion is by a 110 HP turbo charged fresh water cooled Yanmar diesel engine with Hurth reduction gear, coupled to a monel shaft and then to a three blade feathering propeller. The shaft and shaft log, are in good condition. The engine and gear appear in good condition, very clean and well maintained. Ventilation to the engine spaces is adequate. The exhaust (most can be inspected) system is cast and rubber, heavy duty, and in good condition. The system clamps are now all doubled and have had recent service.
