JAMES CROSS, Certified Marine Surveyor

Re: 2004 Hunter 386 Sloop

This letter reports the results of a survey of the above vessel which was inspected on the 21st of May, 2015, while hauled at Merri-Mar Boat Yard in Newburyport, Massachusetts. You requested the inspection to establish its condition and value.

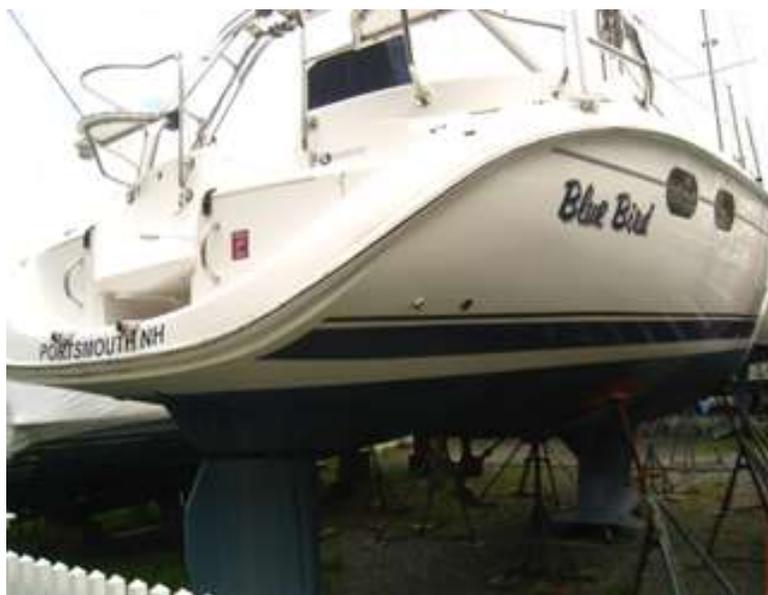
This vessel was designed and heavily built to withstand years of off shore yacht service. She is an aft cockpit cruising sloop rigged for high performance and comfortable ocean cruising.

The hull is a solid polyester laminate reinforced with fiberglass mat and Kevlar, and woven roving. The hull is hand laid up fiberglass. The deck is similar, but with some end grain balsa core and plywood core for backing. The freeboard finish is the original factory gel coating, presently waxed and clean, and has

been well maintained. The hull area from the boot top to the gunwale is in excellent condition and free from noticeable blemishes. The hull from the boot top down was sounded with a metal mallet and found to be solid and free from soft spots or any delamination. The lead ballast is properly fitted and secured via large stainless keel bolts. The keel attachment is secure.

The floor timbers and sole make up are in good condition and secure. The bulkheads are glass tabbed to the hull. The glass tabbing throughout is excellent. The rudder and rudder post are delaminated and need to be repaired. The quadrant and related gear is in good condition. The wheel, pedestals, quadrant, cables, and all related steering gear is in good, well main-

It does, however, need repairs to the rudder.

Recommendations: Ensure that a complete Coast Guard safety and signalling package is aboard, Tag the engine room auto fire suppression system. Make minor repair to companionway hatch slide. Repair rudder. Check all electronics and 120 volt systems when you have your launch,

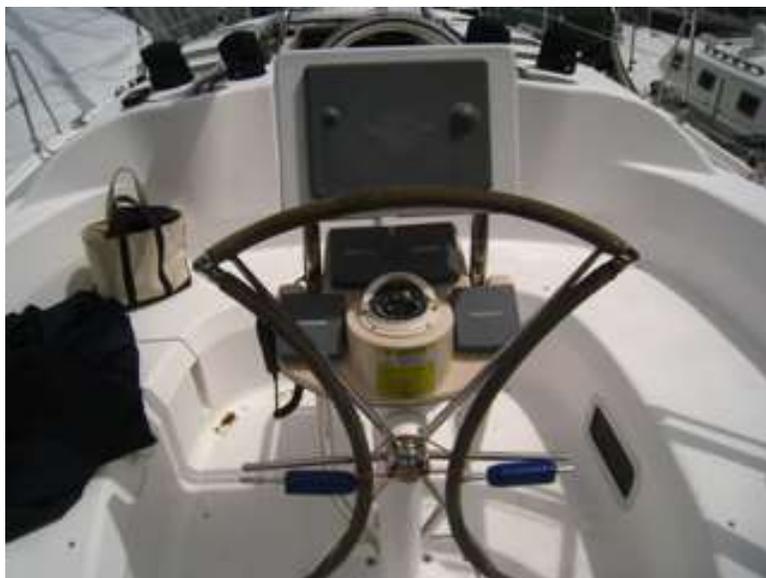
The topsides are a cored laminate with proper hardware backing, well secured, and are in good condition with no abrasions or damage. No soft spots were noted on the deck. The bow and stern pulpits and life line stanchions are constructed of stainless steel and properly secured and backed. The life lines and their associated stanchions and gates are in excellent condition. The cockpit area is self bailing, through large scuppers. This area is clean, and the

finish is in excellent condition. There are a few scratches, but they are superficial and typical for this age vessel. Engine instrumentation is located on the port cockpit seat, within easy reach, while operating under power. The overall condition of the cockpit is excellent. The appearance from on deck, including the trim, is better than average. There is a compass properly secured and the bearing is correct on the present heading. The gusher, a hand operated bilge pump, is installed and operated from the cockpit.

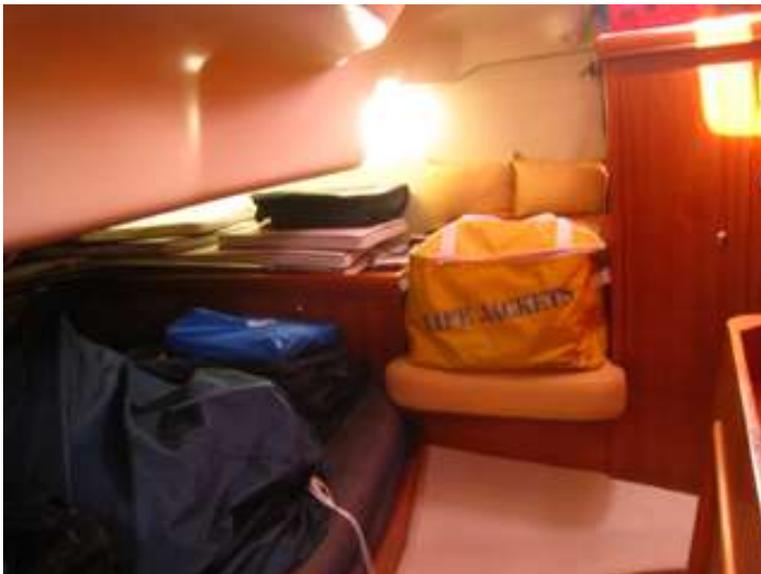
There are two VHF transceiver installed in the Navigation area. There are a number of 10 Kidde installed. These devices are in good condition. There are PFD's, a proper throw ring, and life ring in good condition. I did observe signaling equipment and a First Aid kit. There is an adequately sized plow type anchor with appropriate line (3/8" chain) properly mounted on rollers at the bow. The ground tackle is more than adequate and in good condition. Proper heavy duty backup ground tackle is not on board.

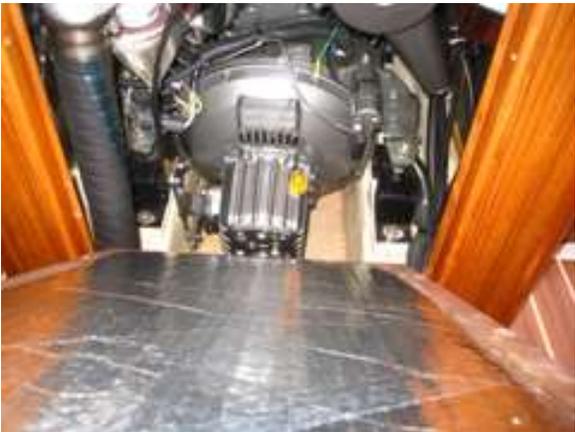
Propulsion is by a 30 KW turbo charged fresh water cooled Yanmar diesel engine with Hurth reduction gear, coupled to a monel shaft and then to a three blade propeller. The shaft and shaft log, are in good condition. The engine and gear appear in good condition, very clean and well maintained. Ventilation to the engine spaces is adequate. The exhaust (most can be inspected) system is cast and rubber, heavy duty, and in good condition. The system clamps are all doubled and have had recent service. All through hull fittings including the valves are secure. The engine controls and cables are smooth operating. The engine compartment bilge is epoxy painted, sound and sturdy. The bilge in this area is clean. There are adequate bilge pumps installed, including a high water max pump, and working in this area. There is no oil in the bilge. All fuel and water tanks are in good condition as can be inspected. The fuel lines, including the filters are approved type and in good condition. The flex fuel line appears to be a recent upgrade. The fuel fills, vents and shut-off are in good order.

The auto fire suppression system should be inspected and tagged.
