June 12, 2015

Re: 1983 Rhode Island Marine Services 45 Fishing Vessel

This letter reports the results of a survey of the above vessel which was inspected while hauled on the 10th of June 2015, at the Wickford Marina in Wickford, Rhode Island. You requested the inspection to establish it's condition and value. I have made only a visual inspections of the engine and gears.

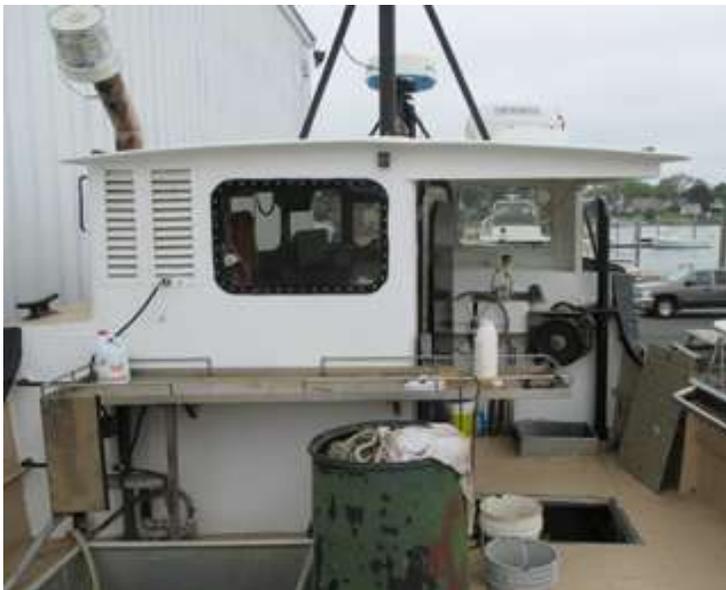
The pilot house/operating station is constructed for the most part of the same Corten steel. The frames and supports are in good condition and no structural rust detected at any location. The windows are Lexan through bolted in place and are secure. Access to the pilot house is gained through a weather tight steel, dogged door. The overhead also is secure and sturdy. Two operating stations are fully functional at this level. The engine control panel (all gauges and switches) is functional. Engine alarms are via panel warning lights. The pot hauler controls are secure and properly mounted.

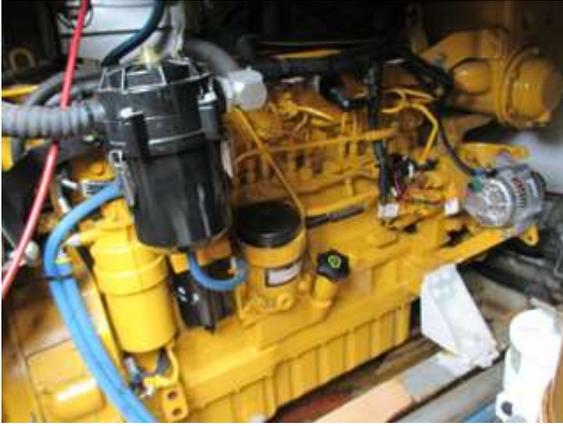
Propulsion is by a 425 HP fresh water cooled John Deere turbo charged Diesel engine with Twin Disk gear 2-1 reduction gear, coupled to a stainless shaft and 26X26 inch bronze five blade propeller. The shaft and shaft log are in good condition. The engine and gears are in good condition, very clean and (installed New in 2011) appear well maintained. The power takeoff, hydraulic from derive gear box is in good condition and provides adequate power for the Hydro Slave hydraulic pot hauler and salt water deck and tank supply system. Ventilation to the engine spaces is adequate. The exhaust, water cooled to the deck plate, is a vertical dry system. The system was completely inspected. (Also fairly New) It is stainless and cast, heavy duty, and in good condition. The system is properly insulated clamped and in good shape. All through hull fittings including the valves are bronze and in good condition.

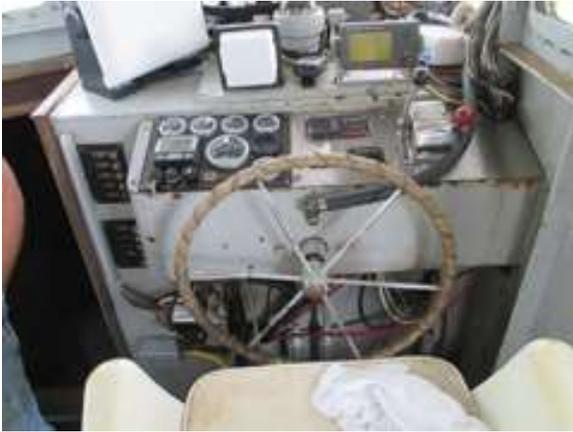
Pilot house operating station

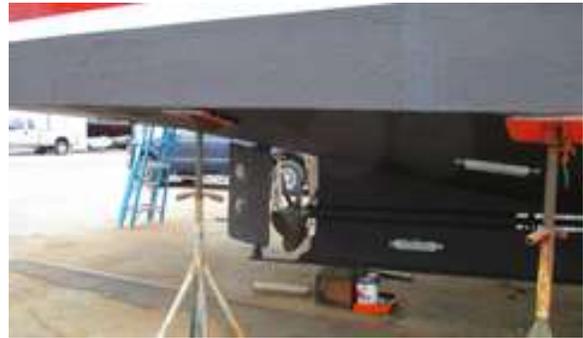
Keel and running gear

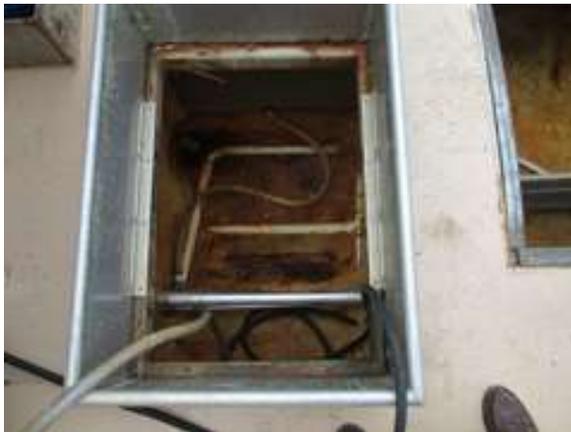
View of one of two insulated holds

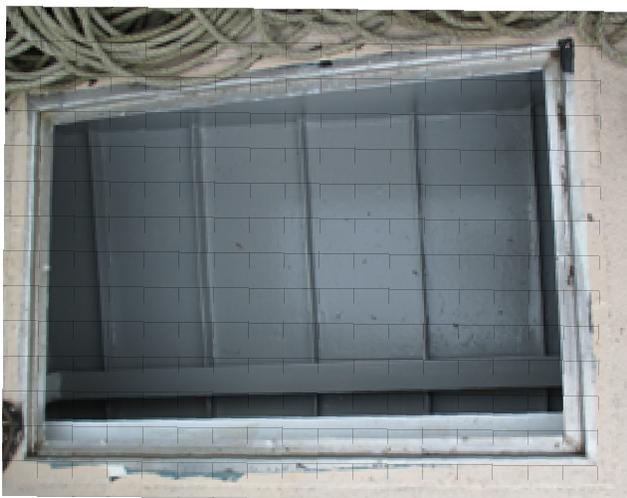
View of hull interior makeup

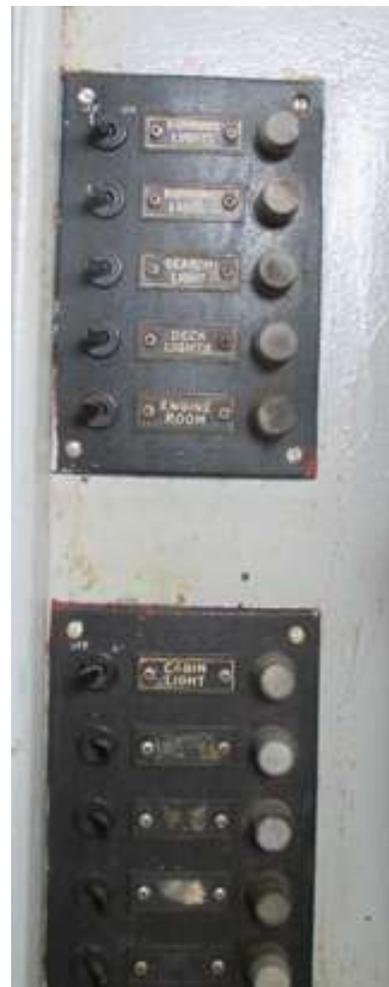
DC control panel

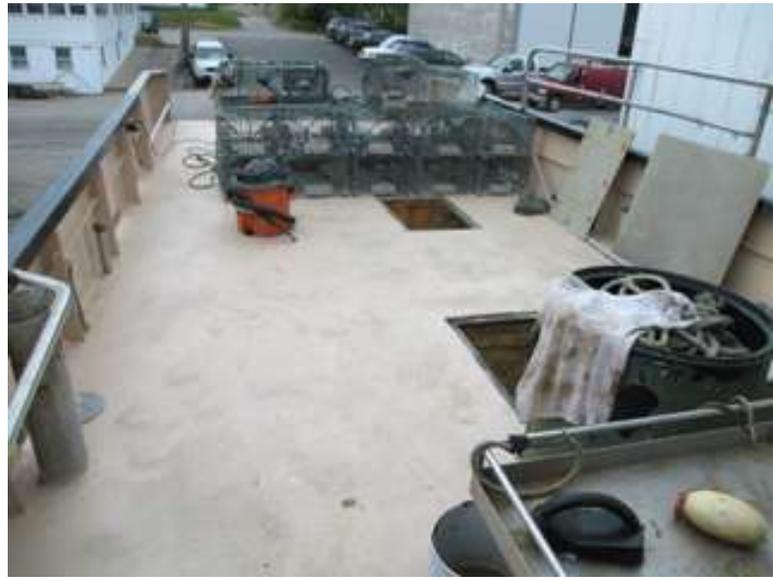
Work deck
