JAMES J. CROSS Jr., Certified Marine Surveyor

Re: 1999 Sea Ray Model 380 Sundancer

This letter reports the results of a survey of the above vessel which was inspected while hauled and afloat on the 20th of October 2015, at Brewers Marina in Warwick, Rhode Island. You requested the inspection to establish it's condition and value.

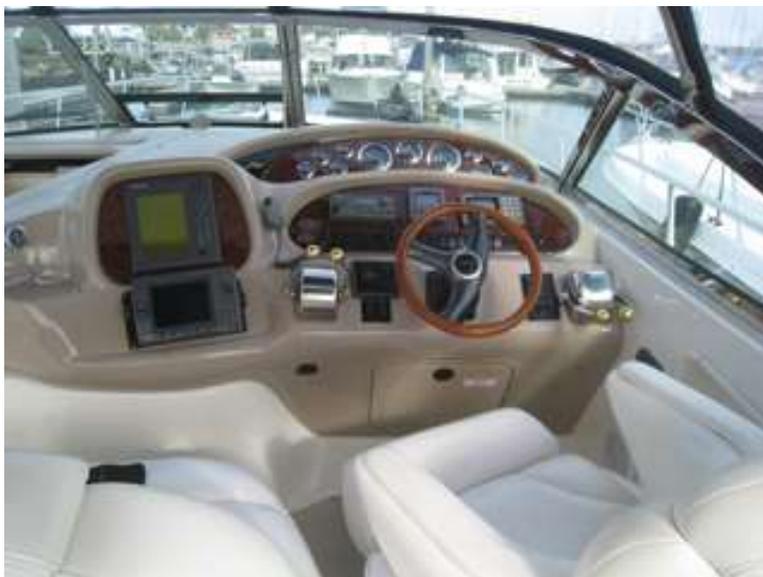
The cockpit area, including the deck, hatches, carpet, and upholstery is in excellent condition. The vinyl upholstery is a recent upgrade and looks new. The operating station is well designed and the controls easy to operate. The compass is accurate on it's present bearing. The throttles operate smoothly. The shifts and steering (steering is Power) are also smooth operating. Access to the engine spaces is gained through a large motorized hatch in the deck of the cockpit area. The main hatch is sturdy and secure. The fiberglass deck (in good condition) is carpeted with an indoor/outdoor type marine color keyed carpet. The aft deck upholstery (vinyl) is also in like new condition. The windscreen is free from any type of damage and has been well maintained. A wet bar with sink is installed in this

aft area. The sink, ice maker and swim shower is also in good condition.

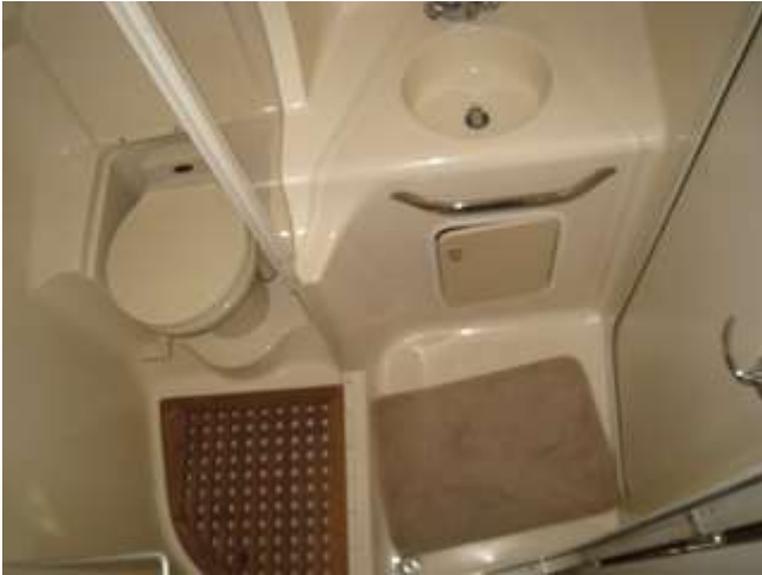
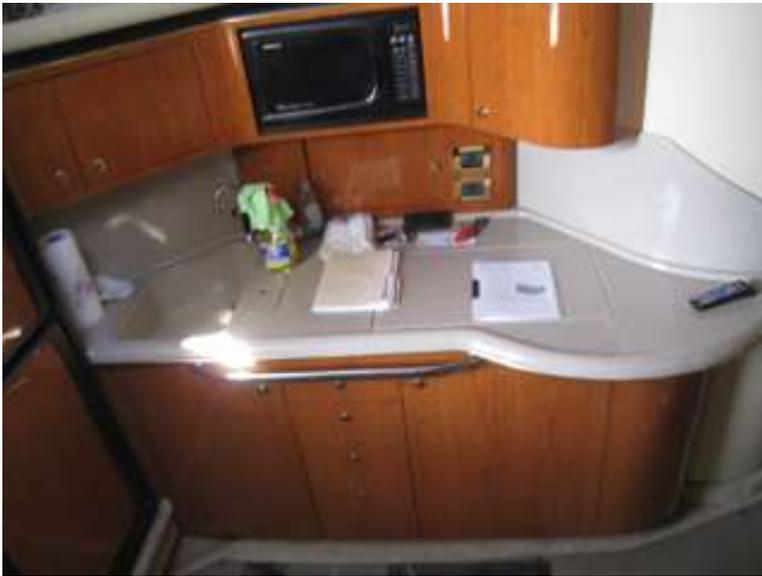
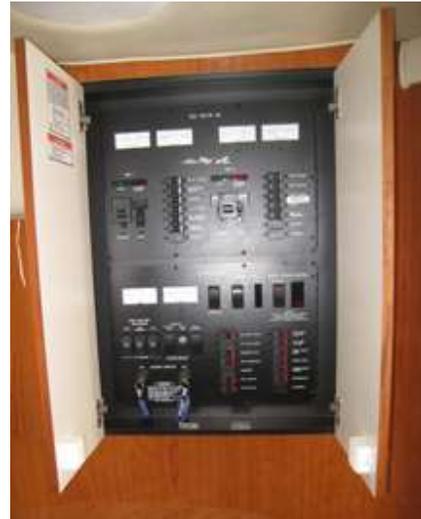
The head is also in very good, clean condition. It houses a standard Vaccu-flush electric marine toilet, shower and hand basin. The shower unit is an integral part of the inner liner. The shower drains into a sump pump arrangement and is then pumped overboard. From the appearance of the plumbing, carpet, and other fixtures, including the galley gear this vessel has been lightly used, and certainly not abused. A plastic holding tank and related plumbing and pump out fixtures appear in serviceable condition. The macerator operated but was not tested. The hot and cold potable water system is also in good shape.

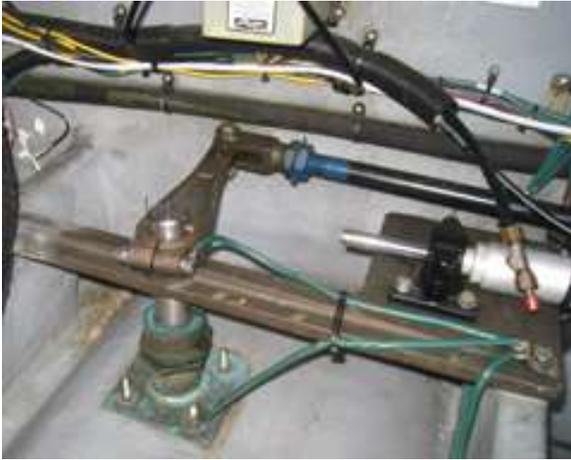
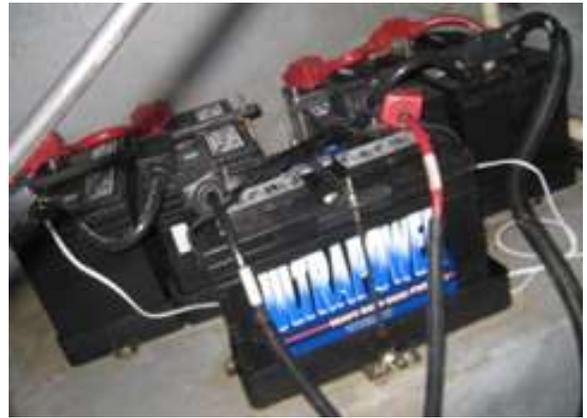
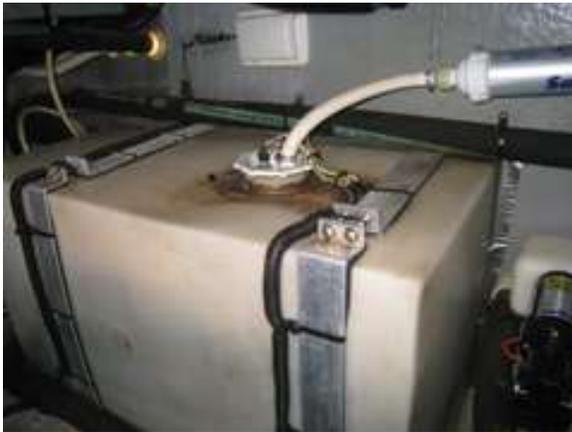
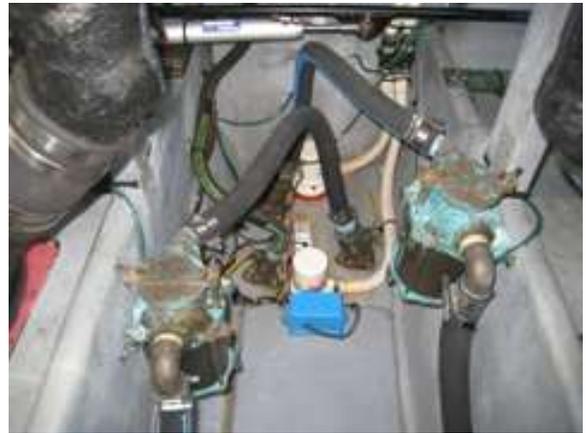
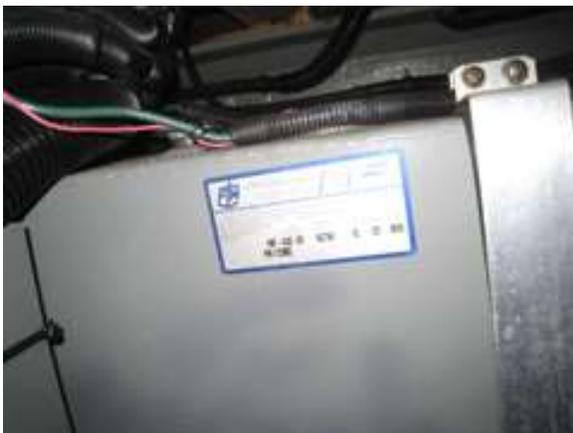
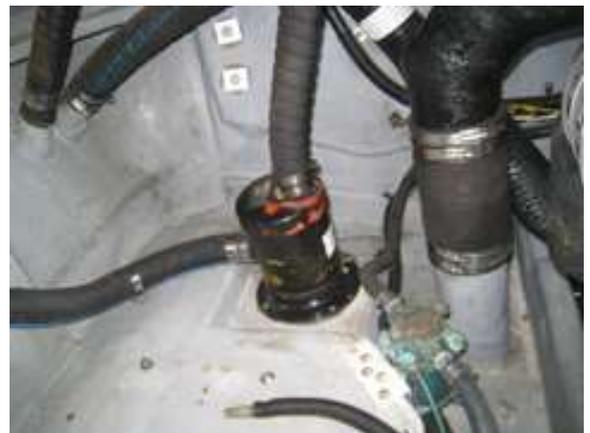
The photos on this page indicate an extremely well cared for and clean bilge, engine room, fuel, and waste tank, exhaust system components and over-board systems.

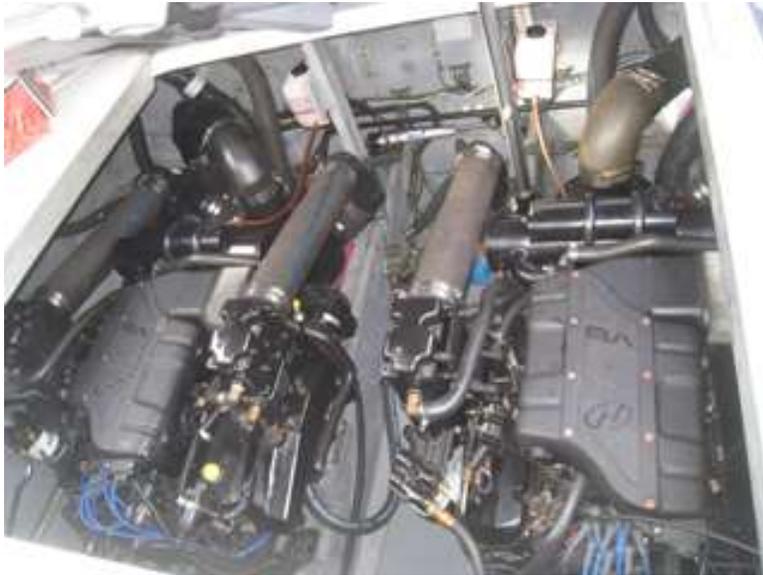
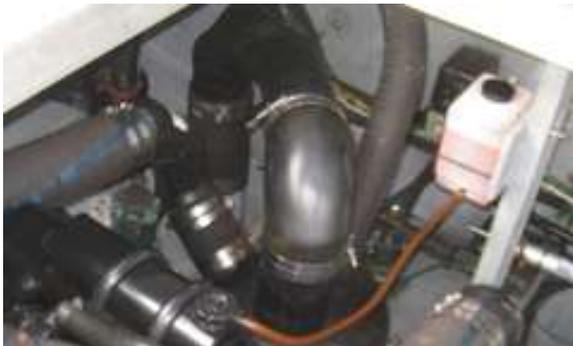
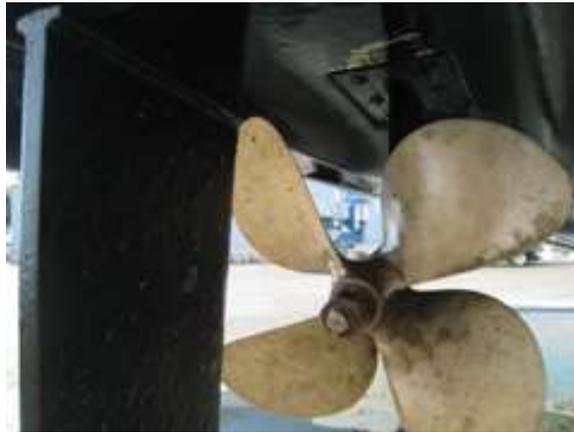
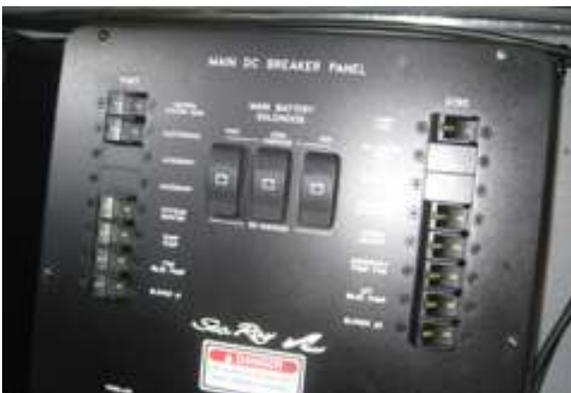
Propulsion is by a pair of fresh water cooled counter rotating "V" eight cylinder (454CID) MAG MPI Horizon Fuel Injected Mer-Cruiser gasoline engines with Mer-Cruiser V drives, Approximately 380 HP each. The monel shafts, and rubber cutlass bearings are in good shape. The rudder shafts, bronze rudder towers, and shaft logs are in good condition. Visual inspection of the engines, oil, filters, coolant, and related connections show that a good maintenance regime is in effect. Approved bilge blowers

and hoses are installed and working. There are two bilge pumps mounted in the bilge, and functioning. The fuel tank is aluminum, (approximately 275 gallons) Fuel lines and valves appear to be upgrades,

no brittle lines were noted. Electric/hydraulic trim tabs are sized and installed. There is no trace of oil in the bilge, and the bilge is clean overall. The exhaust systems including large fiberglass silencers is also in good condition. All bronze valves and salt water devices in the engine compartment are in good condition and properly bonded.

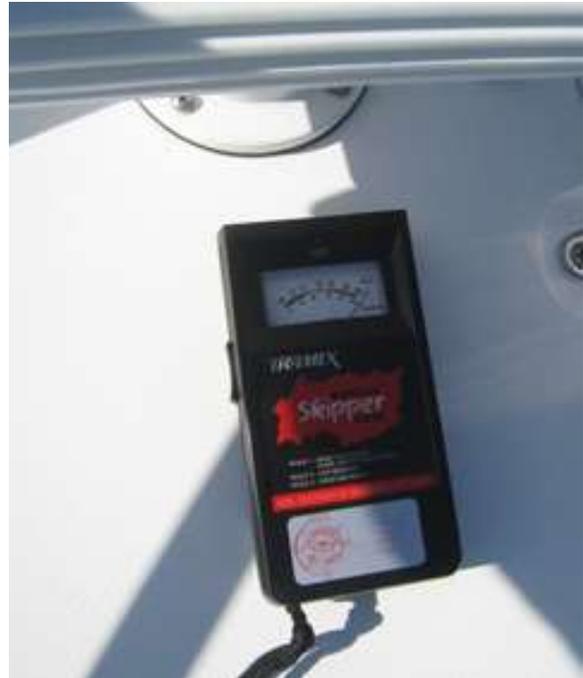
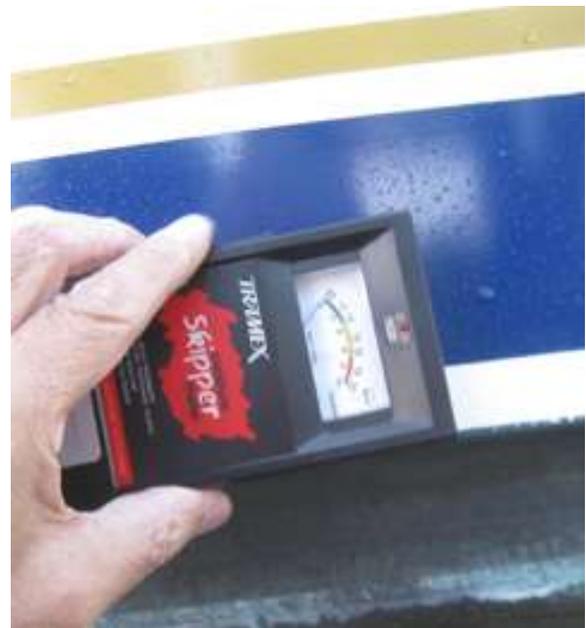
Fig. 2

At the conclusion of the "on water test" the vessel was hauled out for a bottom and running gear check. The bottom was sounded with a metal mallet (thoroughly) and found to free from voids, blisters, or any type of deformity. The bottom paint is in fairly good shape with very little excess build up. No hull repairs were noted. The running gear which includes the propeller shafts, struts, propellers, and rudders was found to be sound and secure. The swim platform, while well secured, does show that several poor quality stainless fasteners should be replaced. (No rush) The trim planes are operational and well secured. Note Fig. 1 & 2 for photos of sample laminate moisture readings.
