**JAMES CROSS, Certified Marine Surveyor**

May 11, 2013

Re: 1978 30' Tartan Sloop

This letter reports the results of a survey of the above vessel which was inspected on the 10th of May 2013, at Brewers Marina in Warwick, Rhode Island, while hauled. You requested the inspection to establish its condition and value.

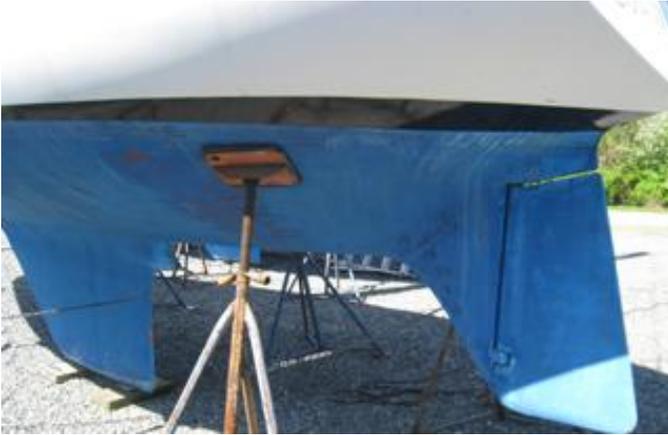
## Hull and structures

lated bushings are in good condition. In addition, there is after market wheel steering installed. The wheel, pedestal and all related steering gear is in good condition and working properly. The topsides are off white and in good condition with a few superficial scratches and cracks. All outside wood surfaces and trim are in fair to good condition. There is a provision for an emergency tiller, and the tiller was on board. The bulkheads are glass tabbed to the hull. The glass tabbing throughout is good. There are inner liners throughout the vessel, which comprises

The hull is a polyester laminate reinforced with fiberglass mat and woven roving. The original gel coated freeboard surface has been re-coated and is in good condition and no major dings or scratches were found. I sounded the hull with a mallet and no voids or soft spots were detected. The hull from the boot top down is also in good condition. There is no excess or build up of bottom paint. The lead ballast is contained by the fin keel. It is properly fitted and secured to the structure. The large monel keel bolts look good. The rudder, rudder post, and all related bushings are in good condition. In addition, there is after market wheel steering installed. The wheel, pedestal and all related steering gear is in good condition and working properly. The topsides are off white and in good condition with a few superficial scratches and cracks. All outside wood surfaces and trim are in fair to good condition. There is a provision for an emergency tiller, and the tiller was on board. The bulkheads are glass tabbed to the hull. The glass tabbing throughout is good. There are inner liners throughout the vessel, which comprises some of the interior finish, and the gel coated fiberglass liners (deck and overhead) are in good condition and structurally sound. It is obvious from the appearance of the interior that the vessel has had good care and reasonable maintenance.

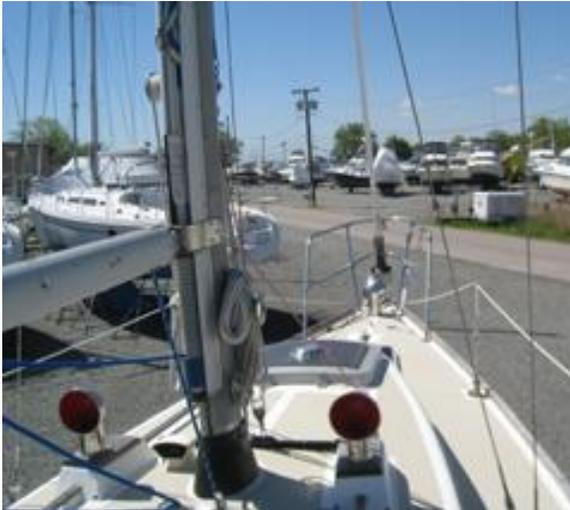
## Standing and Running rigging

The aluminum mast (with internal furler), boom, and related winches and hardware are in good serviceable condition, as can be inspected from on deck. The spreaders are in good condition. The shrouds, and turnbuckles also check out fine. The mast step is well secured, and the mast step shows no signs of corrosion. The step is properly fitted to the keel. All deck hardware, including winches, is properly backed.

There is a jib furling rig installed and it appears in good working order. The hardware is properly sized for this vessel. The winches are properly sized for comfortable cruising. The main sheet traveler is in good condition. The sheets are in good condition as are the halyards. The jib furler feed line looks new. The stainless swim ladder at the stern is in good condition and secure.

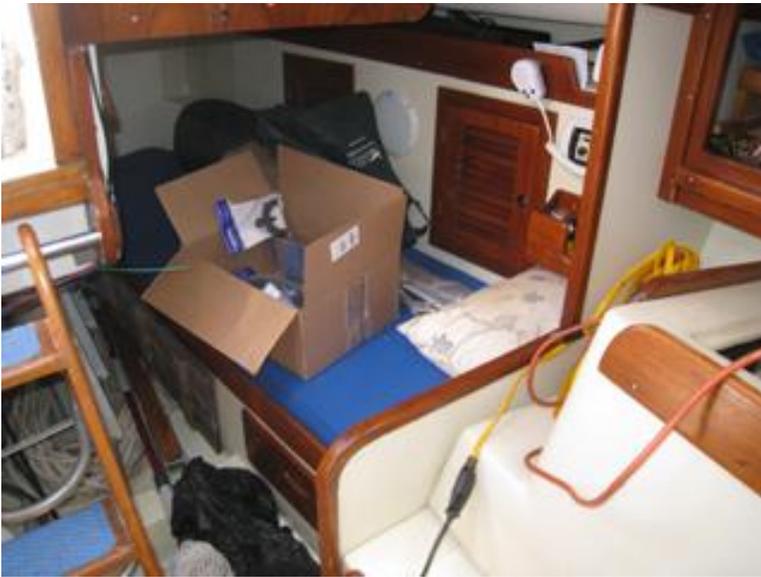
## Main cabin

There is proper ventilation to the main cabin area through vents and ports. The main cabin houses the dinette, galley and head. There is a portable alcohol two burner stove properly secured in the galley. A large ice chest is built in on the right of the stove and extends into the cockpit. The ice chest, stove, and sink are in good condition. There is a pressure hot and cold water system installed. The potable water system is working. Closets, lockers and other storage areas are more than adequate through out the vessel. The interior areas are clean and in fair to

good condition. The joiner work is plywood, and some solid teak, and some with a teak veneer. The joiner work is nicely done and in good condition. The head liner (moulded in) is in good condition. The nylon upholstered sections are in good condition and have many seasons of use ahead of them. The sole is teak and is in fair condition, cosmetically. Access to the bilge is not limited. The dinette table is large and secures to the overhead in the quarter berth for storage. The quarter berth and the main cabin berths will sleep three. A PVC water tank is located under the berth. There is an auto/manual bilge pump installed. The hot water tank is in unknown condition and properly secured.

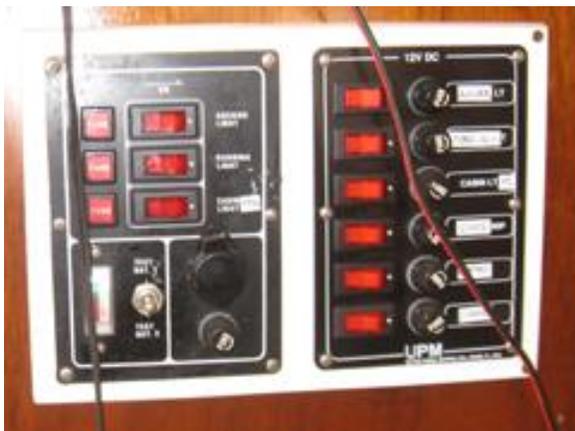
## Electrical

The batteries are properly boxed, covered and secure. The batteries are properly installed. The batteries feed the 12 volt system through a proper three way switch and fuse panel. The panel is in good condition. The electrical wiring and terminals observed throughout the vessel are in good condition, except that some harnessing and terminal service is needed. The circuits were rung out and no problems were found. There was no high resistance noted. The navigation lights comply
