**JAMES CROSS**, Certified Marine Surveyor

Re: 1981 Lash 55 Fishing Vessel "LONG LINE"

This letter reports the results of a survey of the above vessel which was inspected while hauled on the 29th of June 2015, at the Newport Shipyard in Newport, Rhode Island. You requested the inspection to establish it's condition and value. I have made only a visual inspections of the engine, gears, and fishing gear.

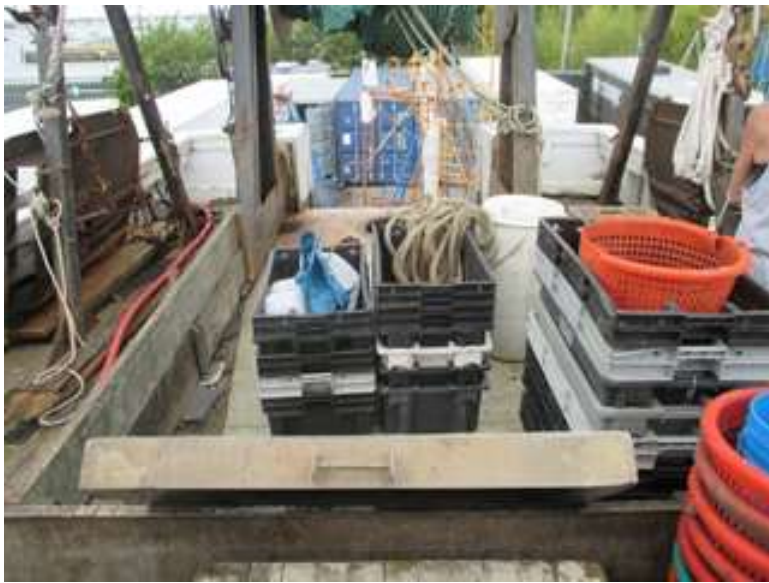
All surfaces were checked out and no problems were found. The work deck, (photos on Page 3 and at left) is also constructed of white oak framing and transverse oak planking reinforced to accommodate load bearing areas. All deck supports and reinforcements are also oak and are well secured.

Several hatches are built in to provide access to a variety of hold spaces. The hold area is divided to provide space for different specie of catch.

The side rails are secure and house tankage (approximately 50,000 pound capacity. The Hydraulic pumps (Three) are properly installed and secure. Two for the winches, one for the net and miscellaneous gear.

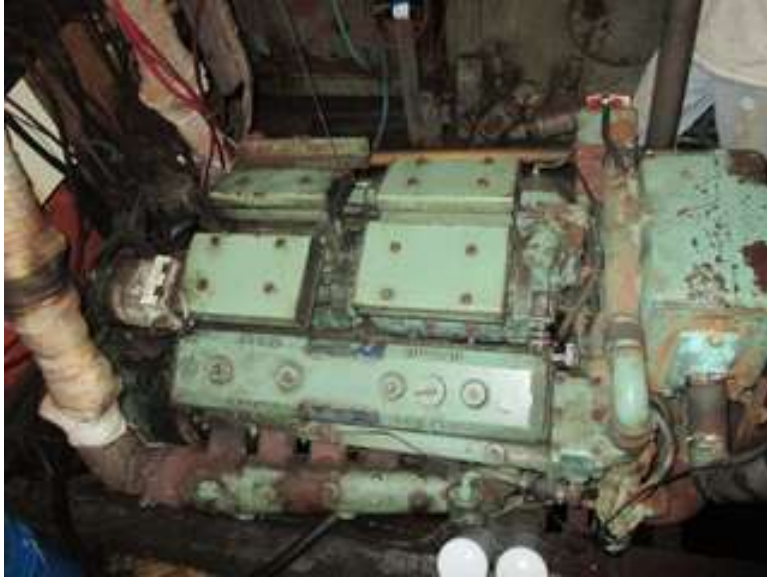
Propulsion is by a 350 HP fresh water cooled Detroit Diesel engine with Twin Disk gear 2-1 reduction gear, coupled to a stainless shaft and 13X13 inch bronze four blade propeller. The shaft and shaft log are in good condition. The engine and gears are in good condition, very clean and (reported to be installed rebuilt in 2010) appear well maintained. The power takeoff, hydraulic from derive gear box is in good condition and provides adequate power for the Hydro Slave hydraulic equipment for deck and tank supply system. Ventilation to the engine spaces

is adequate. The vertical dry exhaust system appears secure, but should be insulated above deck as it passes near work space. It is stainless and cast, heavy duty, and in good condition. The system is properly insulated clamped and in good shape.

All through hull fittings including the valves are bronze and in good condition, but could use freeing up as two in the engine space are quite stiff to operate.

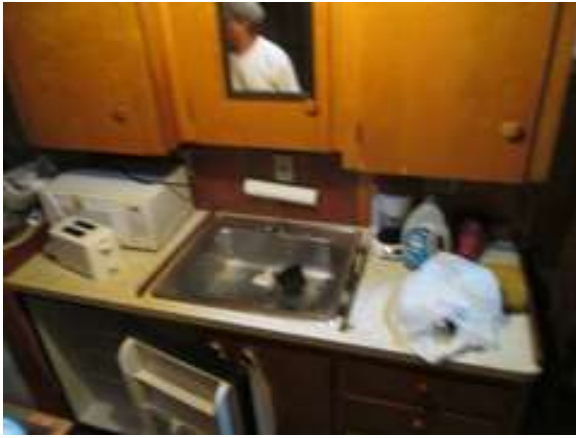
Crews quarters and Galley

The crews quarters and galley occupy the focsle, as usual. The area is spartan, but clean and structurally sound. There are berths for four and a fully equipped galley additional photo on Page 4.
