JAMES CROSS, Certified Marine Surveyor

Re: 2004 Hunter 386 Sloop

This letter reports the results of a survey of the above vessel which was inspected on the 21st of May, 2015, while hauled at Merri-Mar Boat Yard in Newburyport, Massachusetts. You requested the inspection to establish its condition and value.

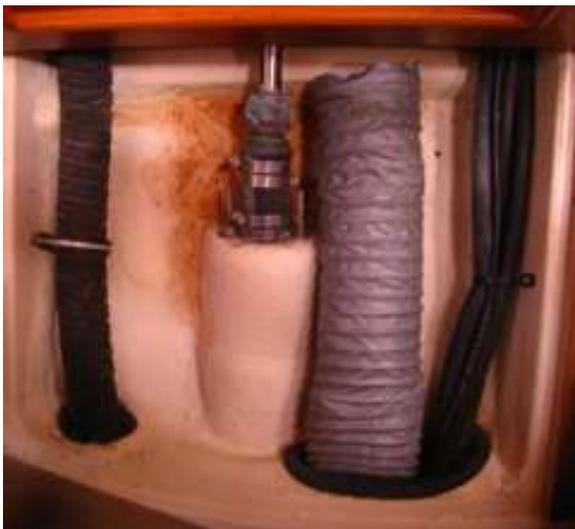
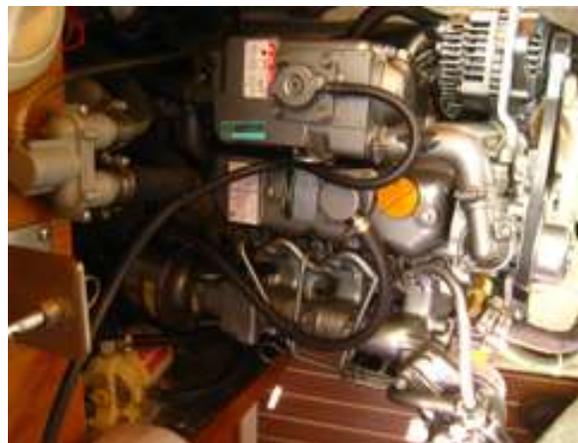
The auto fire suppression system should be inspected and tagged.

Recommendations: Ensure that a complete Coast Guard safety and signalling package is aboard, Tag the engine room auto fire suppression system. Make minor repair to companionway hatch slide. Repair rudder. Check all electronics and 120 volt systems when you have your launch,
