June 12, 2015

Re: 1983 Rhode Island Marine Services 45 Fishing Vessel

This letter reports the results of a survey of the above vessel which was inspected while hauled on the 10th of June 2015, at the Wickford Marina in Wickford, Rhode Island. You requested the inspection to establish it's condition and value. I have made only a visual inspections of the engine and gears.

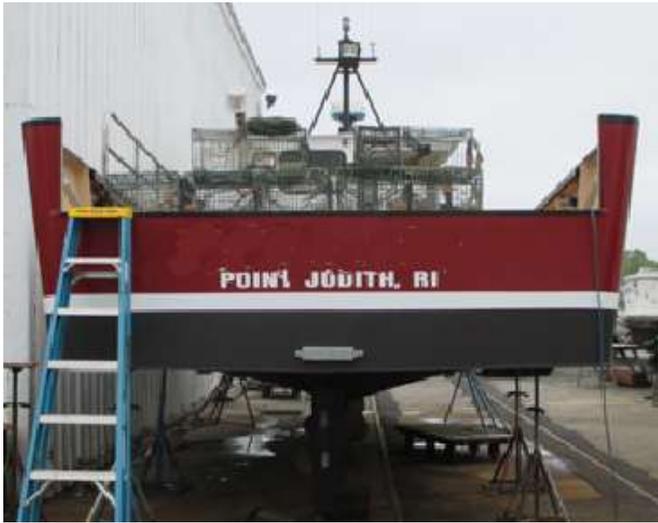
withstand years of off shore service. She is a hard chine, open transom vessel constructed of 3/16 and 1/4 inch Corten alloy steel welded plates (bottom and freeboard) over 1/4 inch by 2 to 4 inch frames on angular and welded longitudinal stringers. The (keelson) keel makeup is comprised of twin 1/2" by 14" by (3/4 length of vessel) plate strong backs cut and welded to the proper shape. The longitudinals are also 1/4" Corten alloy steel of varying width stock sizes. Six water tight bulkheads are installed within the structure. The deck is steel plate, properly supported and sturdy. The decks are also 1/4" plate over 1/4" by 2" steel frame construction. The keel (skeg) is open 1/2" by 4" Beam" welded. The closed Beam" will also serve to

support and protect the running gear and rudder. This hull design and construction technique make for a very seaworthy craft. The interior view of this hull permits a fairly complete inspection. The frame work and welds are in very good shape with proper penetration and completed in a professional manner. I did not detect any frames or other supporting structures that were questionable. Actually, the work on this vessel is a notch above that of most professional vessel yards engaged in this type of vessel construction. The exterior below the waterline section of the hull was inspected and found to be free from rust and fair. This design calls for three water tight compartments. A new coat of epoxy paint has just been applied. Bilge pumps and alarms are in operational condition.

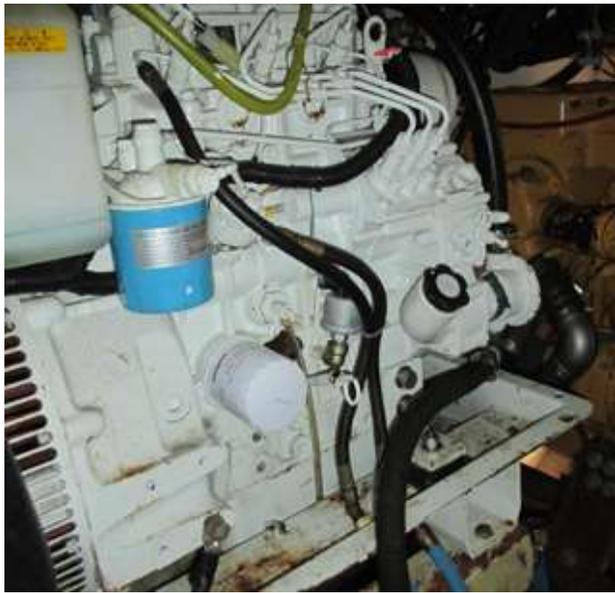
Propulsion is by a 425 HP fresh water cooled John Deere turbo charged Diesel engine with Twin Disk gear 2-1 reduction gear, coupled to a stainless shaft and 26X26 inch bronze five blade propeller. The shaft and shaft log are in good condition. The engine and gears are in good condition, very clean and (installed New in 2011) appear well maintained. The power takeoff, hydraulic from derive gear box is in good condition and provides adequate power for the Hydro Slave hydraulic pot hauler and salt water deck and tank supply system. Ventilation to the engine spaces is adequate. The exhaust, water cooled to the deck plate, is a vertical dry system. The system was completely inspected. (Also fairly New) It is stainless and cast, heavy duty, and in good condition. The system is properly insulated clamped and in good shape. All through hull fittings including the valves are bronze and in good condition.

The engine controls from both stations are smooth operating. The engine compartment bilge is sound and sturdy. The bilge in this area is clean. There are three two inch high capacity dewatering pumps. One pump is hydraulic driven and the other two are 240 volt driven. The custom hydraulic manual steering gear is in good condition and operates smoothly from both stations. The rudder shaft packing gland is secure.

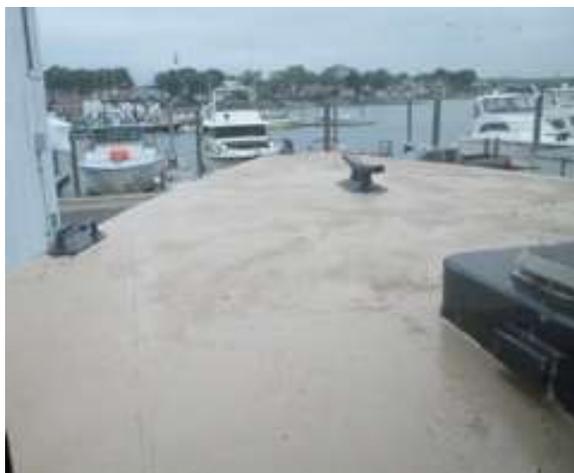
The forward raised deck and bow area is in overall good condition. The deck area is free from rust, freshly painted and in secure condition as is the escape hatch to the crews quarters. The cleats are in good condition and secure.

There are two complete sets of anchors (one fifty pound Danforth) with appropriate chain and line aboard. Backup ground tackle is aboard.
