JAMES J. CROSS Jr., Certified Marine Surveyor

Re: 1999 Sea Ray Model 380 Sundancer

This letter reports the results of a survey of the above vessel which was inspected while hauled and afloat on the 20th of October 2015, at Brewers Marina in Warwick, Rhode Island. You requested the inspection to establish it's condition and value.

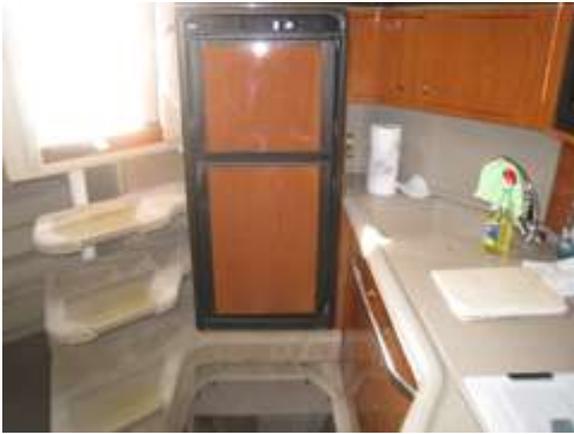
Main Cabin/ General

The main cabin houses the salon-dinette, galley, and forward and aft berth areas. This area is spacious, nicely finished and in very good to excellent condition. The entire area is carpeted with a plush, color keyed, mold resistant nylon material. The vinyl headliner is clean, in good condition and secure. The upholstered sections, bulkheads, and joiner work show very good care and maintenance. The Corian moulded counter top in the galley is in good shape.

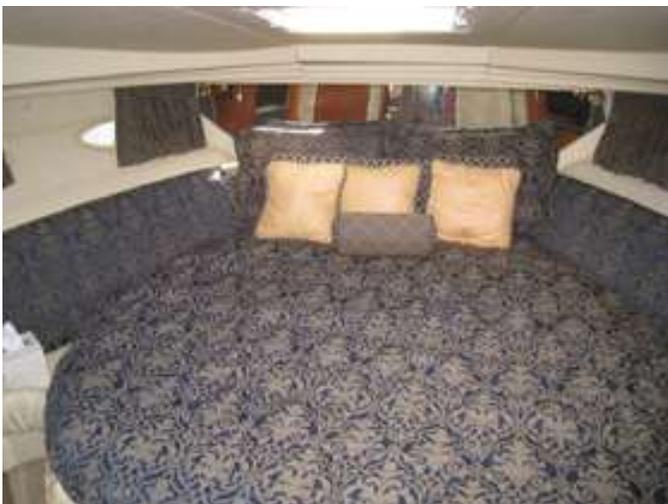
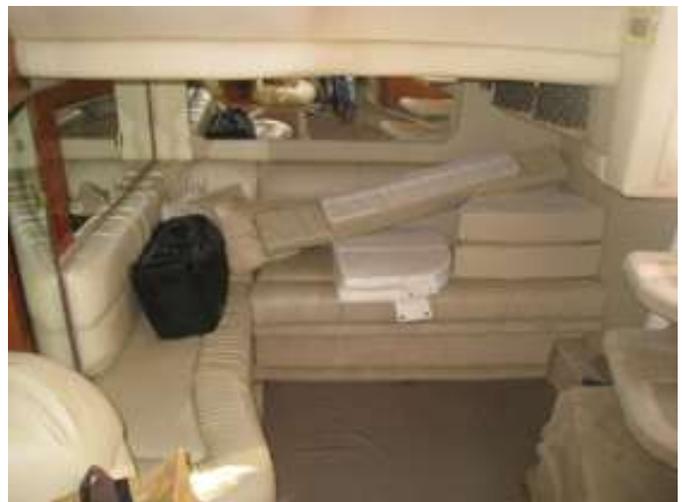
The aft berth is located just under the operating station and is in about the same good condition as the forward berth. The upholstery is also in clean and in overall very good shape. The dinette (space for four) is clean, nicely upholstered (original vinyl), and folds down to provide a berth. It is just across from the galley and head.

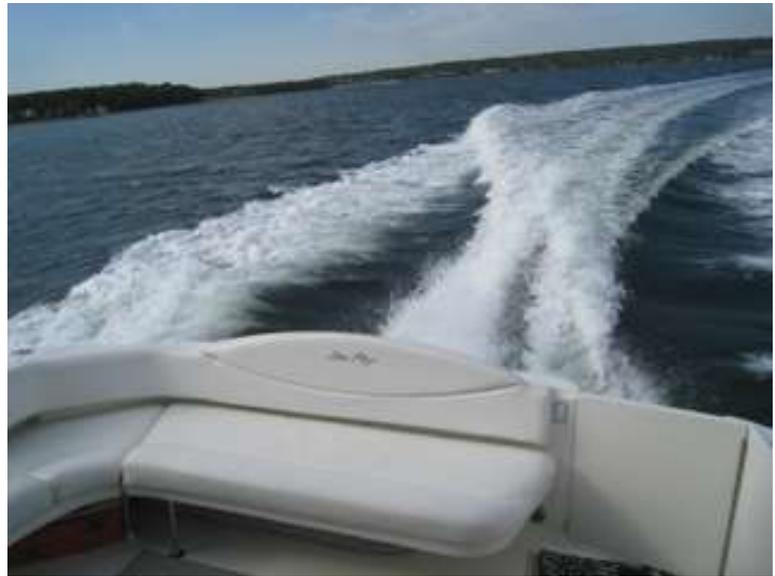
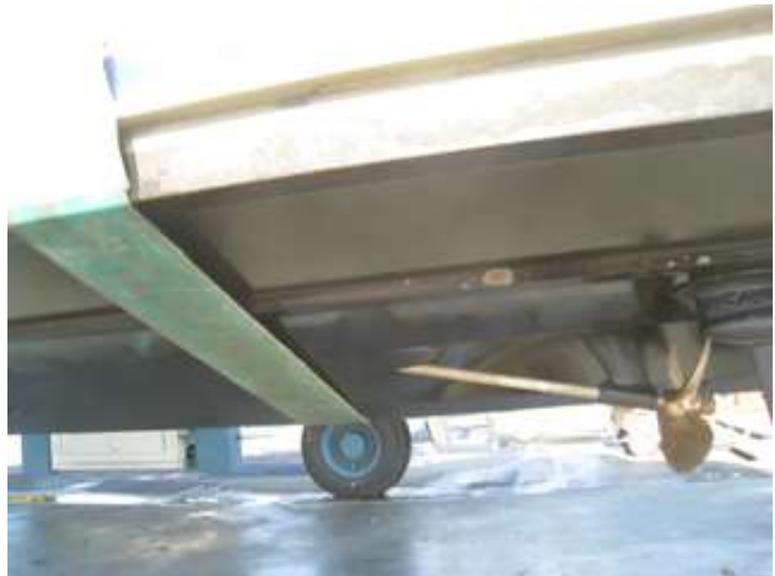
At the conclusion of the "on water test" the vessel was hauled out for a bottom and running gear check. The bottom was sounded with a metal mallet (thoroughly) and found to free from voids, blisters, or any type of deformity. The bottom paint is in fairly good shape with very little excess build up. No hull repairs were noted. The running gear which includes the propeller shafts, struts, propellers, and rudders was found to be sound and secure. The swim platform, while well secured, does show that several poor quality stainless fasteners should be replaced. (No rush) The trim planes are operational and well secured. Note Fig. 1 & 2 for photos of sample laminate moisture readings.
