**JAMES CROSS, Certified Marine Surveyor**

May 11, 2013

Re: 1978 30' Tartan Sloop

This letter reports the results of a survey of the above vessel which was inspected on the 10th of May 2013, at Brewers Marina in Warwick, Rhode Island, while hauled. You requested the inspection to establish its condition and value.

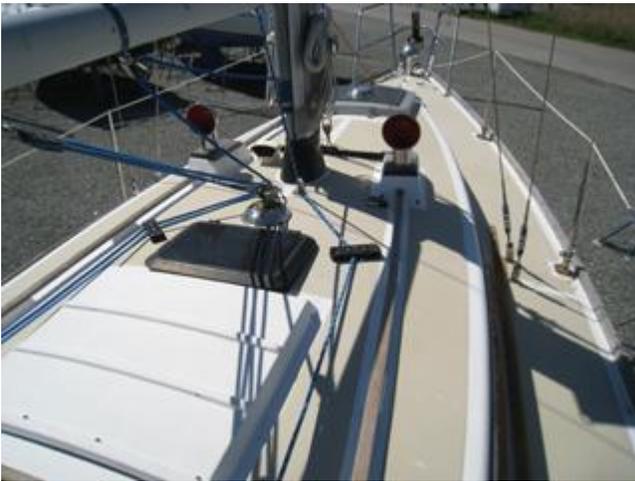
The hull is a polyester laminate reinforced with fiberglass mat and woven roving. The original gel coated freeboard surface has been re-coated and is in good condition and no major dings or scratches were found. I sounded the hull with a mallet and no voids or soft spots were detected. The hull from the boot top down is also in good condition. There is no excess or build up of bottom paint. The lead ballast is contained by the fin keel. It is properly fitted and secured to the structure. The large monel keel bolts look good. The rudder, rudder post, and all related bushings are in good condition. In addition, there is after market wheel steering installed. The wheel, pedestal and all related steering gear is in good condition and working properly. The topsides are off white and in good condition with a few superficial scratches and cracks. All outside wood surfaces and trim are in fair to good condition. There is a provision for an emergency tiller, and the tiller was on board. The bulkheads are glass tabbed to the hull. The glass tabbing throughout is good. There are inner liners throughout the vessel, which comprises some of the interior finish, and the gel coated fiberglass liners (deck and overhead) are in good condition and structurally sound. It is obvious from the appearance of the interior that the vessel has had good care and reasonable maintenance.

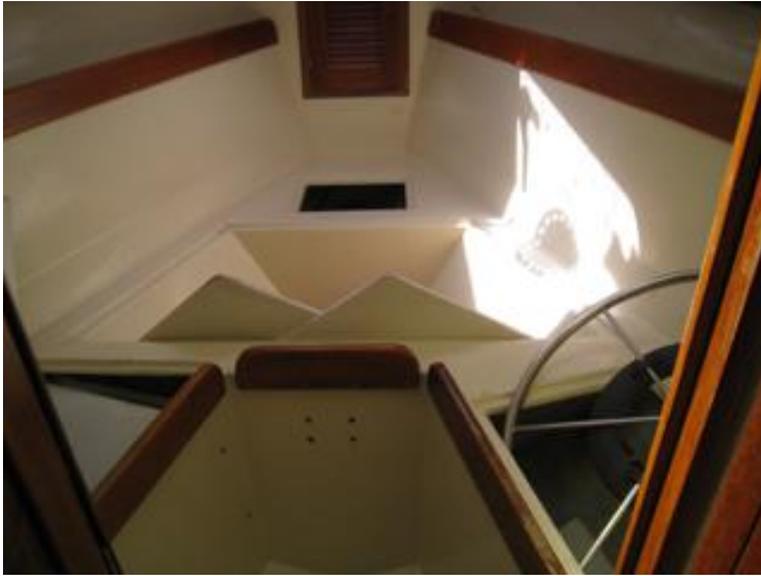
The V-Berth is located beneath the forward deck. This area will sleep two. It is clean and nicely upholstered. (upholstery in storage for winter) There is adequate lighting and locker space in this area. Also, housed in the V-berth area are several PFD's and rode storage at the forepeak. The deck hatch to this area is tight to the weather and in good condition. The holding tank hardware is located under the berth. No odor was noted. The head

plumbing is secure. No fresh water was left in the tank, so by the time we got to the head there was no water to check the hand wash basin and shower.
